Marine Case Study – Settling Pond

Polk County, Florida

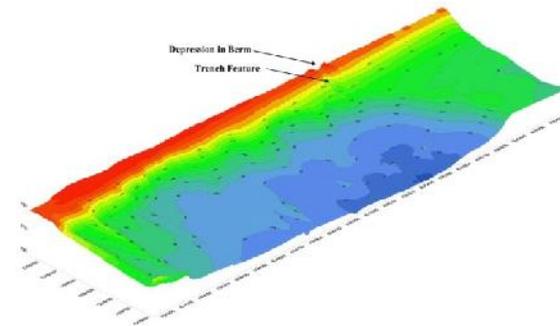
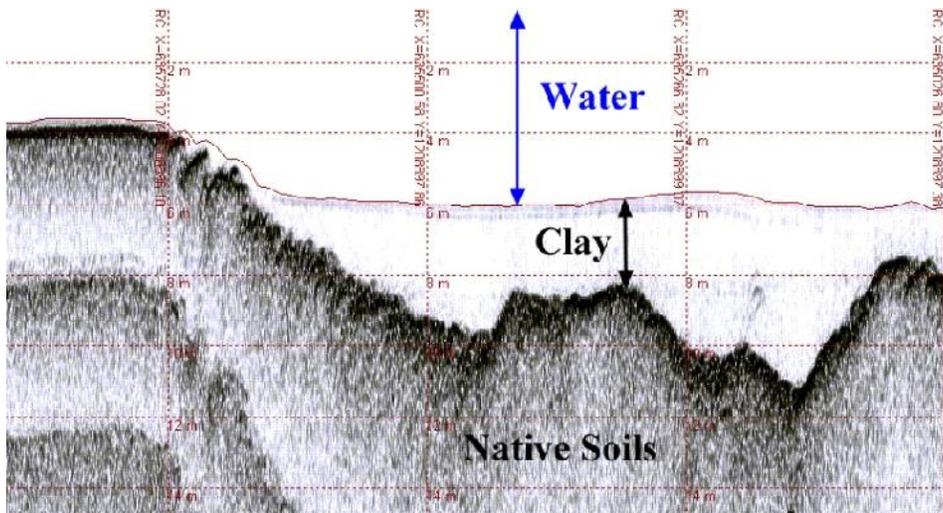
The data was processed using Hypack© and SonarWiz.Map©. Contour maps of the elevation of the seafloor, the thickness of the marine sediment, and elevation of the top of rock were produced. The results showed a shallow trench feature extending towards the location of the depression of the dam. The trench feature appeared to be approximately 2 to 4 ft in depth and located only within the sediments, not within the underlying rock. The trench feature extends from an area of alleged dredging towards the depression. There is no indication that the trench feature is a result of sinkhole activity. The results suggested that the depression in the dam was the result of the loss of embankment soil material due to dredging activity rather than sinkhole activity.
